# Manhole Inspection Summary

Manhole # S37QQ\_009MH

**Location** Address: **611 GUTMAN AVE**

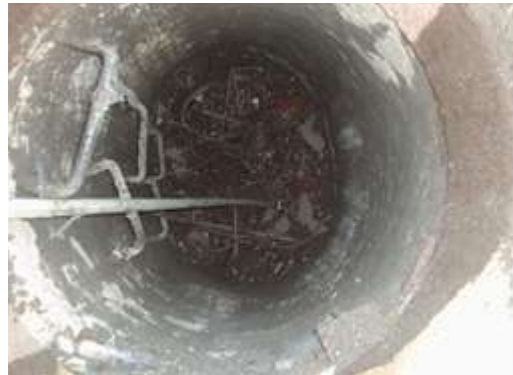
Top View

Channel debris.

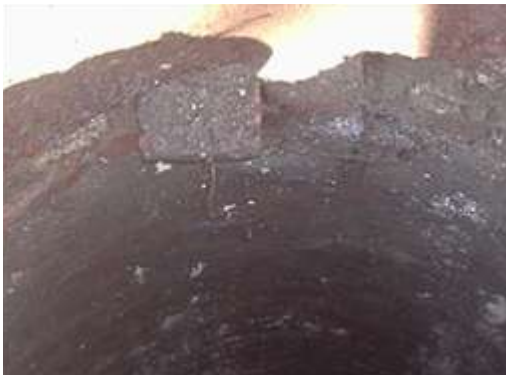
Defect

Frame leaks. Adjustment deterioration, loose brick and infiltration.

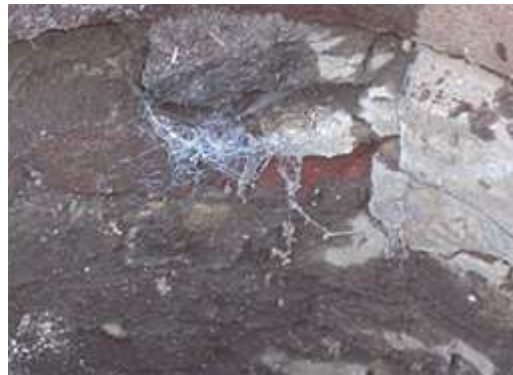
Defect

Frame leaks. Adjustment deterioration and infiltration.

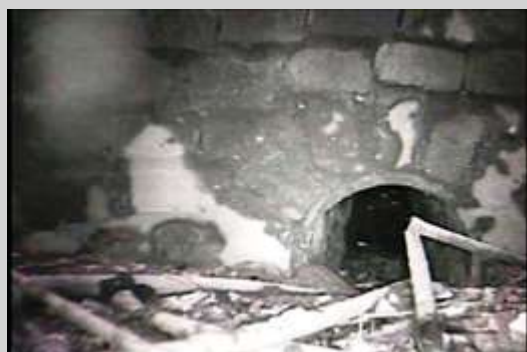
Pipe Out @ 12 O'Clock

Deposits: ☐ None ☒ **Mud** ☐ Sludge ☒ **Debris** ☐ Grease

Silt Depth: **1** (in.)

Deposits Extent: **Light**
